International Conference on Overhead Lines

Testing and Validation of Implosive Splices for Passing Through Stringing Travelers

A Case Study of SCE's TRTP Project

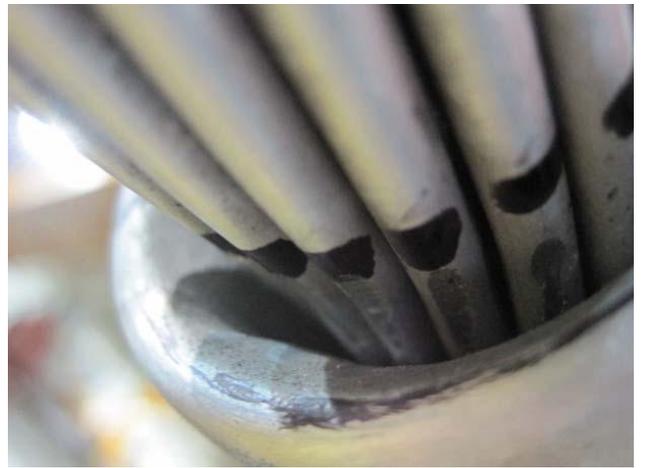
Figure 4. Localized conductor strand flattening at 50 degree tensile test. (1590 ACSR Lapwing splice)

Result: No conductor strand damage was observed in all of the tests through the various vertical angle tests. However, localized flattening of the outermost strands was observed to varying degrees depending on the tension and vertical angle of the tests. For the tests performed at the 30 deg vertical angle, little or no flattening was observed. For the tests performed at the 40 deg vertical angle, minor localized flattening was observed. For the tests performed at the 50 deg vertical angle, localized flattening of the conductor strands was observed, as seen in Fig. 4.
